METALS HANDBOOK

VOL. 9
FRACTOGRAPHY AND ATLAS OF FRACTOGRAPHY

8th EDITION

Fractography and Atlas of Fractographs

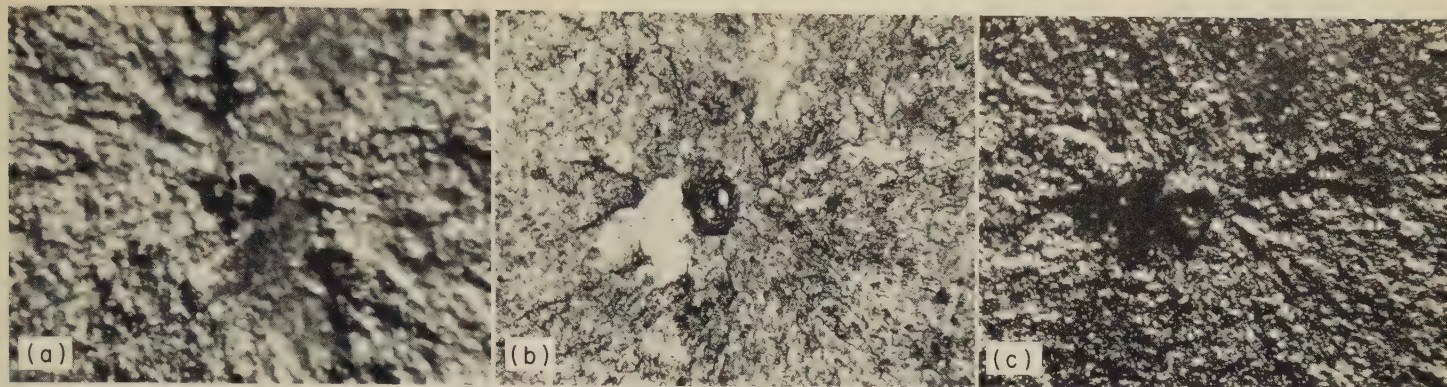
Light fractographs
 (a) Replica photographed with oblique illumination from a point-source lamp. (c) Replica shadowed with a vapor-deposited coating and photographed using oblique illumination from a point-source lamp.
 (b) Same area of replica as (a), photographed with transmitted light.

Fig. 2. Comparison of three fractographs of a cellulose acetate replica of a fatigue fracture in an induction-hardened shaft of 15B28 steel. Fracture was initiated by the large inclusion shown in the center of the views, during rotating bending.

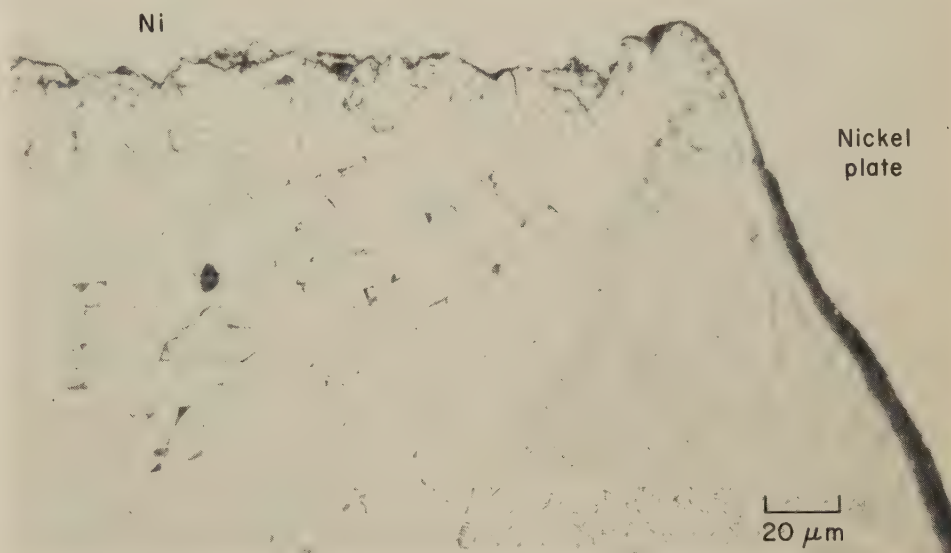
Micrograph (etchant: picral)

Fig. 3. Profile of a stress-corrosion crack in welded low-carbon steel pipe. Fracture surface is at top; weld is at right; external surface of the pipe is at far right. Protective nickel plate shows along the entire length of both edges.

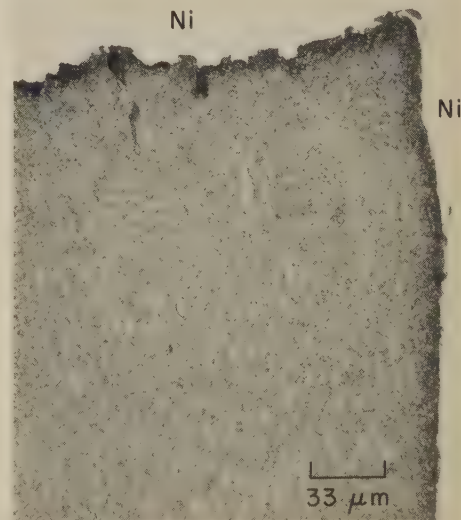
Micrograph (etchant: picral)

Fig. 4. Profile (at top) of a fracture in 8620 steel. A protective nickel plate has preserved the fracture outline.

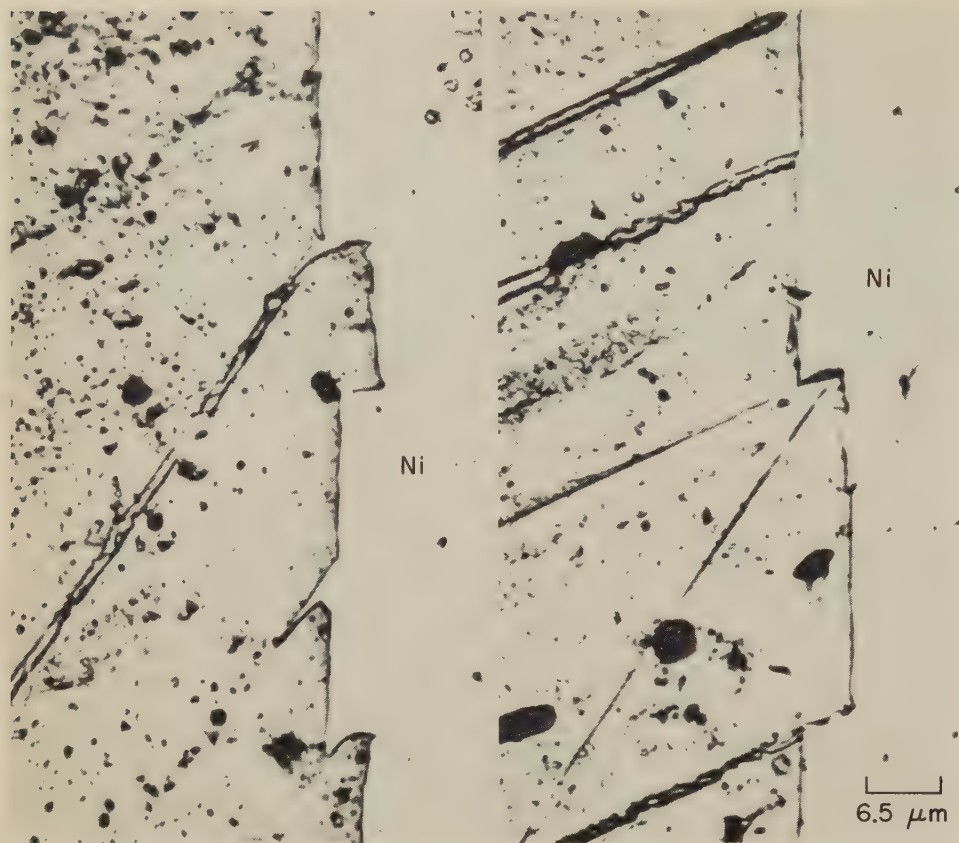
Micrograph (etchant: 10% nital)

A protective nickel plate has preserved the fracture outlines. Fracture was produced by an impact bend test at -70°C (-94°F), and is mainly on $\{100\}$ planes, with deviations on $\{112\}$ planes. (E. P. Klier, A Study of Cleavage Surfaces in Ferrite, *Trans Am Soc Metals*, Vol 43, 1951, p 935-957, Fig. 31)

Fig. 5. Two portions of the surface (shown in profile) of a cleavage fracture in a specimen of essentially pure iron

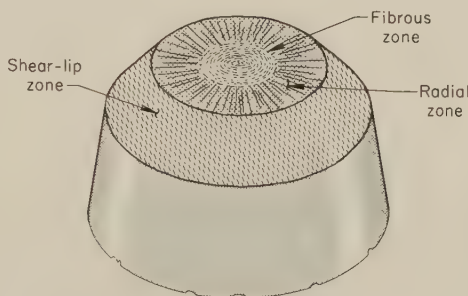
Fig. 1. Schematic representation of zones within a typical tensile fracture of an unnotched, cylindrical specimen. The surfaces of the fibrous and radial zones are usually normal to the tensile axis, as shown. The shear-lip surface is always at about 45° to the tensile axis.

Tensile-fracture surface marks have been classified into three zones by configuration (Ref 1, 2)—namely, (a) the fibrous zone, (b) the radial zone, and (c) the shear-lip zone. The three zones are illustrated schematically in Fig. 1.

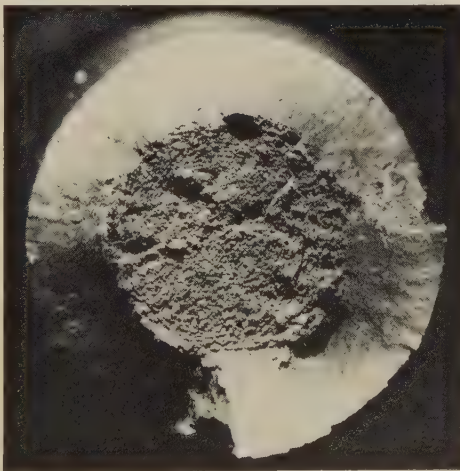
Light fractograph About 11×
Fracture in a tensile-test specimen of 4340 steel that was tested at 120 C (248 F). The structure of the steel was tempered martensite; hardness was Rockwell C 46. Fracture started at the center of the fibrous zone, which exhibits circumferential ridges. The outer ring is the shear-lip zone.

Fig. 2. Tensile fracture containing a fibrous zone and a shear-lip zone (Ref 2)

The discussion that follows concerning the fracture-surface features illustrated in Fig. 2 to 4 (fibrous zone, radial zone,

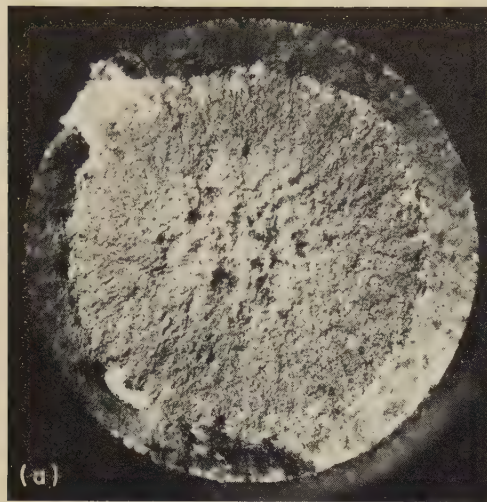
(a) The steel had a pearlitic structure, a hardness of Rockwell C 15, and a yield strength of 483 MPa (70 ksi). The inner zone is randomly fibrous; the zone surrounding this inner zone (inside the outer shear lip) has radial marks. (Ref 2)

Fig. 3. Surfaces of fractures in two tensile-test specimens of 4340 steel with two different structures. Both surfaces contain fibrous, radial and shear-lip zones.

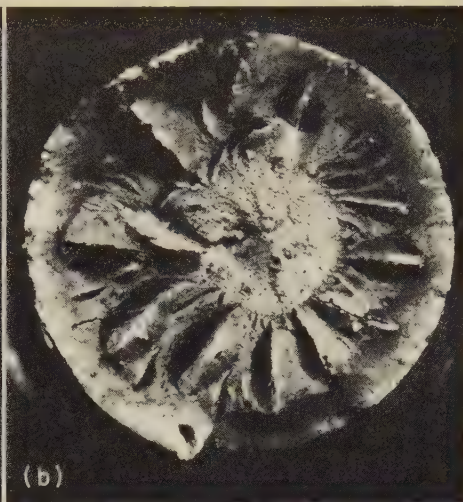
(b) The steel had a structure of tempered martensite and a hardness of Rockwell C 28. The inner, fibrous zone is circumferentially ridged; the intermediate zone has coarse radial marks; the outer ring is the shear-lip zone.

Fracture in a 4340 steel tensile-test specimen tested at room temperature. Structure of the steel was tempered martensite; hardness, Rockwell C 28. The fracture resembles that in Fig. 3(b), but its origin (at the small inclusion) is to left of center, producing the curved radial shear marks.

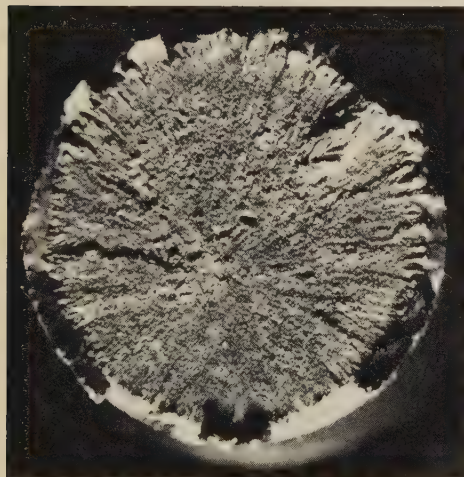
Fracture in an unnotched tensile specimen of 4340 steel that was tested at -196°C (-321°F). The structure of the steel was tempered martensite; the hardness was Rockwell C 35. This fracture has no fibrous zone. The radial marks occupy the entire area inside the narrow shear-lip zone.

Fig. 4. Surface of a tensile fracture containing a radial zone and a shear-lip zone (U. S. Army photograph)

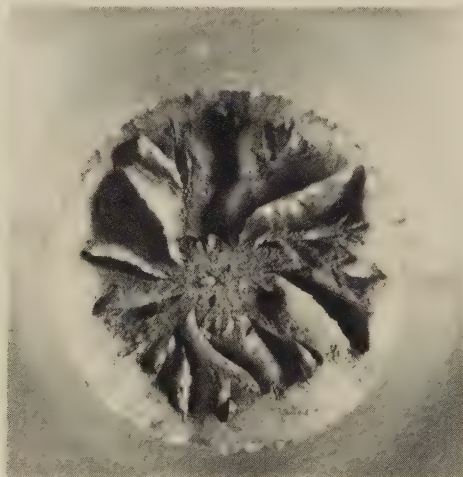
Fig. 5. Surface of a tensile fracture showing curved radial shear marks (U. S. Army photograph)

Usually, radial marks on tensile specimens are straight. If the fibrous zone is very small or is absent, and if the origin of fracture is at a significant distance from the tensile axis, the radial marks deviate from linearity and curve toward either the free surface or the shear lip (as in Fig. 5).

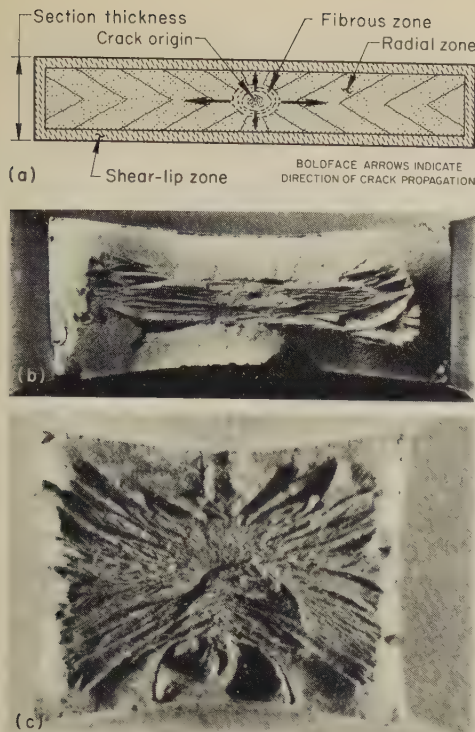
(a) Schematic representation of tensile-fracture features in a specimen with a rectangular cross section. (b) Light fractograph of a rectangular steel specimen with fracture features conforming to those of the diagram. (c) Light fractograph of a rectangular steel specimen with a fracture similar to that of (b) but having a much narrower shear-lip zone.

Fig. 6. Fracture-surface marks in rectangular tension specimens (Ref 2)

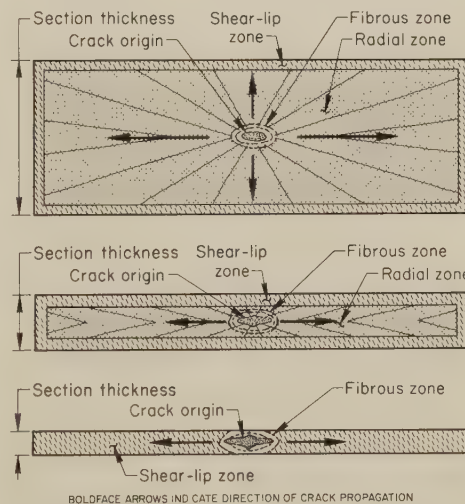
Schematic representation of the change in the size of the radial zone in the fracture surface of rectangular specimens of progressively decreased section thickness. The thinnest of the three examples has a small fibrous zone surrounding the origin and a shear-lip zone, but no radial zone.

Fig. 7. Fracture-surface marks in rectangular tension specimens as affected by section thickness (Ref 2)

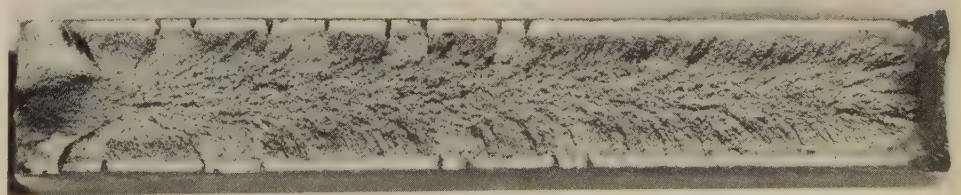
The crack origin is at the left end of the specimen, and is adjoined by a small fibrous zone. The remainder of the fracture surface exhibits the special radial marks known as chevron, or herringbone, patterns. Note that the V's of the chevrons point back toward the crack origin. (U. S. Army photograph)

Fig. 8. Light fractograph of the surface of a high-velocity fracture in a specimen of steel plate, showing chevron patterns

Chevron Patterns. The radial zone of rectangular specimens that have a width appreciably greater than the thickness exhibits chevron, or herringbone, patterns, as shown in Fig. 8. (See also Figs. 13, 14 and 38 in the article on Interpretation of Light-Microscope Fractographs, and fractograph 4273 on page 298 in the Atlas of Fractographs.) Chevron patterns are frequently associated with unstable,

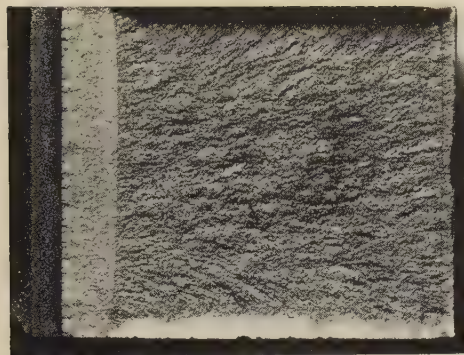
The steel had a structure of tempered martensite and a hardness of Rockwell C 52.5. The machined notch prepared as a crack starter is at the extreme left. At the right of the notch is a zone of penetration by electrical discharge machining (EDM) to provide a sharper notch root. The fatigue crack is immediately to the right of the EDM notch. Test temperature was -73°C (-100°F). (U. S. Army photo)

Fig. 9. Fracture surface of a fracture-toughness bend specimen of 3%Ni-Cr-Mo steel, showing radial marks emanating from a precracked fatigue zone

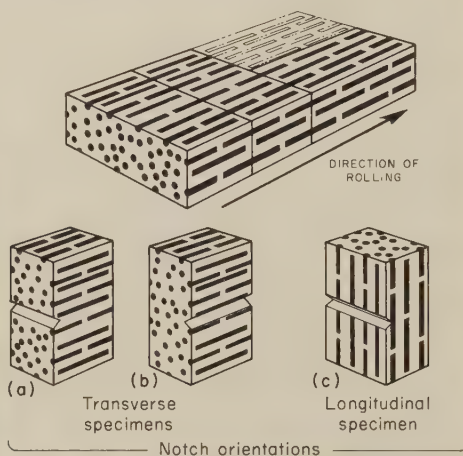
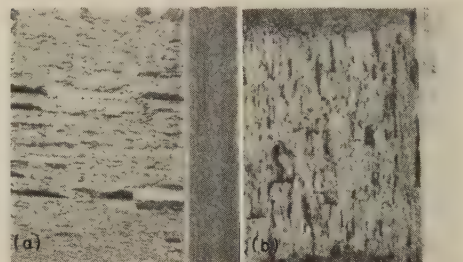
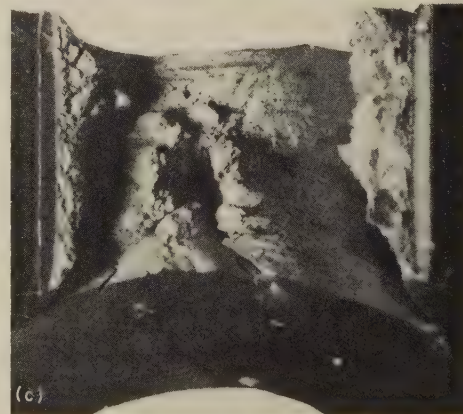
The isometric drawings above show transverse and longitudinal Charpy impact specimens taken from mechanically fibered material. The laminate characteristics of the fracture surfaces (light fractographs, at about $3\frac{1}{2}\times$) are directly related to the notch orientation in each example. (Ref 2)

Fig. 11. Woody fracture surfaces of notched specimens of a binary iron alloy

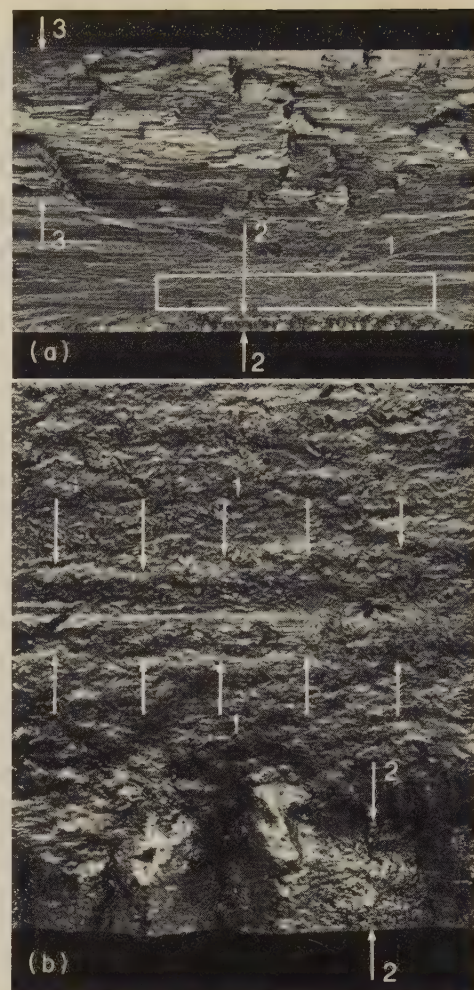
Light fractographs Actual size (a); $10\times$ (b)

The fatigue crack originated at a large alumina inclusion — within rectangle 1 in fractograph (a) and between arrows 1 in (b). Crack followed the approximate direction of the longitudinal plane of maximum shear stress, propagating in all directions from the inclusion to a final length of 1 ft. Beach marks are not evident because the mating surfaces rubbed. At the hardened case (between arrows 2), the crack changed direction to follow the 45° planes of maximum tensile stress. In the shaft interior, the crack propagated on many parallel and slightly offset shear planes, forming a woody fracture surface, as between arrows 3. The upper edge of fractograph (a) is a cut that was made after fracture.

Fig. 12. (a) Segment of a woody fracture resulting from torsional fatigue in a carburized and hardened shaft of aircraft-quality 9310 steel; profile of one surface of the shaft is at bottom. (b) Region at the shaft surface at the bottom of fractograph (a), at higher magnification.

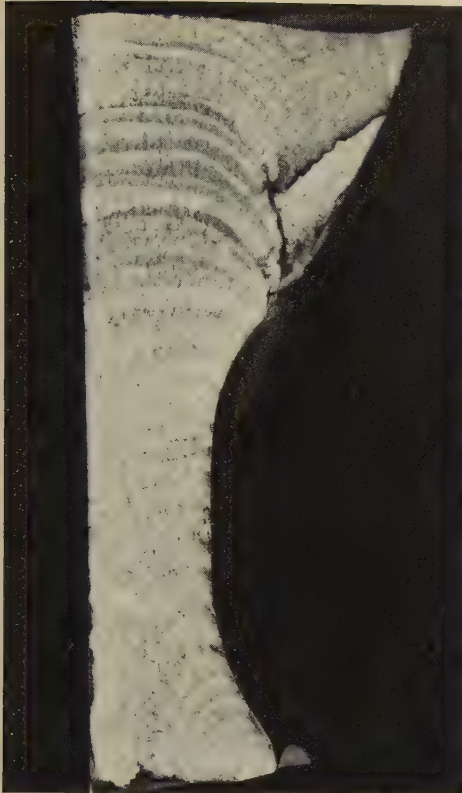
The light-colored, reflective bands are zones of slow crack propagation. At high magnifications, thousands of fatigue striations can be resolved within each band. The dull, fibrous bands are zones of crack propagation by microvoid coalescence.

Fig. 13. Beach marks on a fatigue fracture in an aluminum alloy 7075-T73 forging

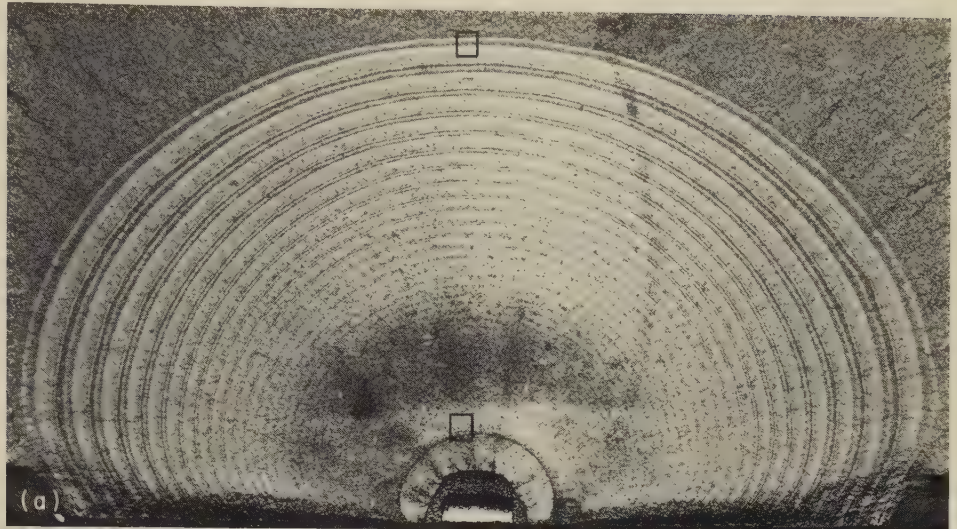
(a) Plate subjected to a series of varied loading cycles in the laboratory, which produced the series of beach marks. The crack origin, at the bottom center, was at a starter notch formed by electrical discharge machining.

Fig. 15. Three views of a fatigue fracture in D-6ac steel plate, showing beach marks (Ref 5)

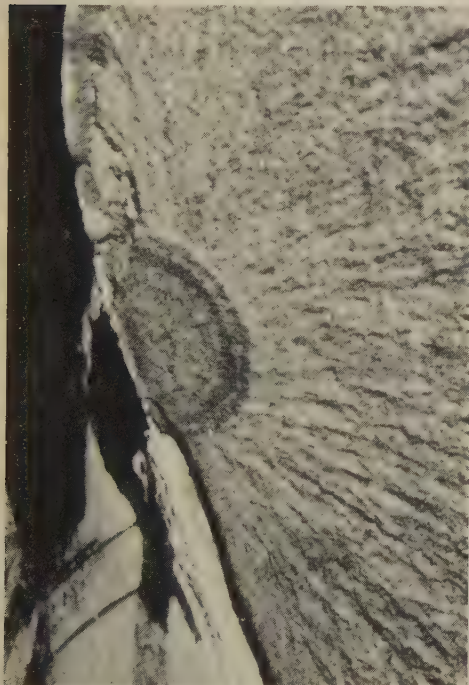
Tensile strength of the steel was 1780 to 1903 MPa (260 to 280 ksi). The beach marks are the result of differences in the rate of penetration of corrosion on the surface. They are in no way related to fatigue marks.

Fig. 14. Beach marks on a 4340 steel part that were caused by stress-corrosion cracking

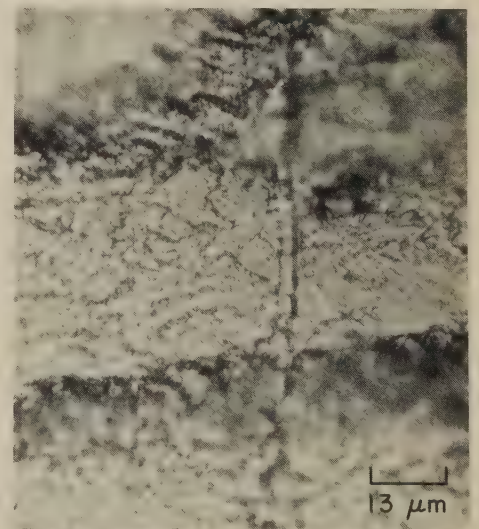
Fig. 16. Fatigue striations in aluminum alloy 7075-T651 plate. Note the fine, closely spaced, vertical striations at the left of the vertical step.

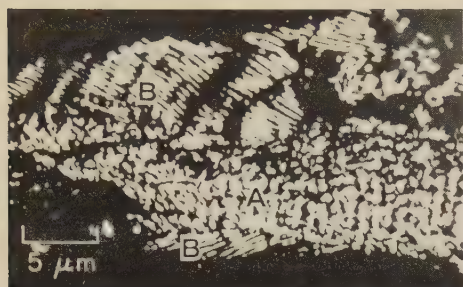
Light fractograph 2000×
Fig. 17. Brittle (A) and ductile (B) striations in high-strength aluminum alloy 7178-T6. The brittle striations always lead and the ductile striations trail off, like the wake of a ship.

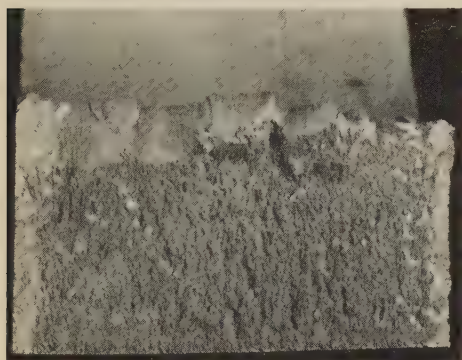
Light fractograph 7½×
Fig. 18. Ratchet marks in aluminum alloy 7075-T6 plate. The stepped appearance of these marks is characteristic whenever fatigue cracks emanate from several sites and later join to form one primary crack front.

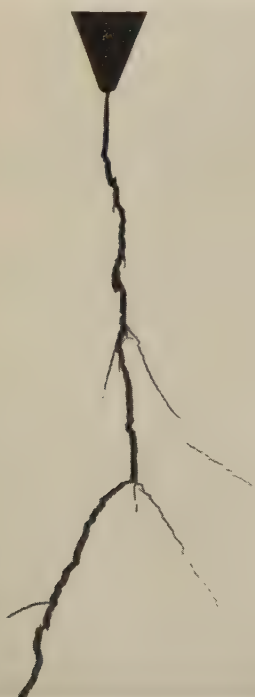
Macrograph (as polished; not etched) 3×
The crack was caused by dripping a 3¼% NaCl solution into the notch of a cantilever-bending tear-test specimen during testing. The microstructure of the steel was martensitic.

Fig. 19. Section through a stress-corrosion crack in high-strength 0.45% C, 9% Ni, 4% Co steel showing crack branching

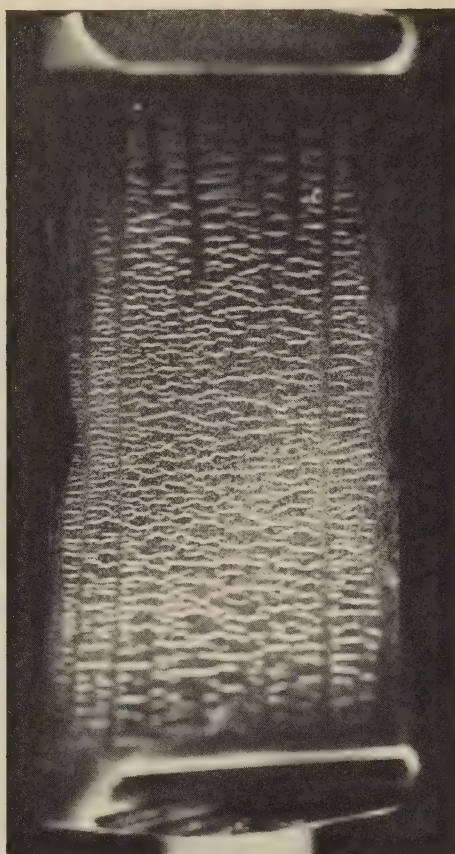
Photograph Actual size
Fig. 20. Photograph taken under ultraviolet light of dye-penetrant indications showing extensive secondary cracking in a forging of high-strength 4340 (mod) steel with tensile strength of 1760 to 2070 MPa (270 to 300 ksi)

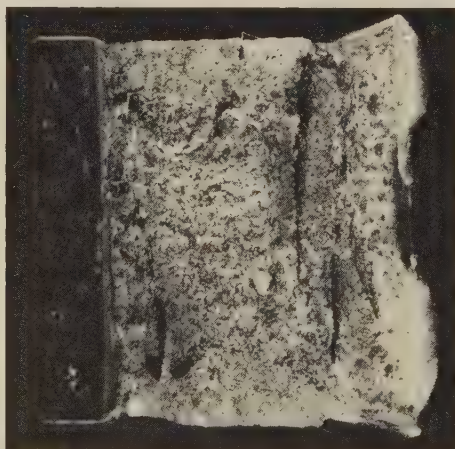
Light fractograph 5×
Fig. 21. Transverse secondary cracking in a Charpy impact specimen of ASTM A514, type F, structural steel at 760-MPa (110-ksi) tensile strength. Impact energy absorbed was 75 ft-lb at 27 C (80 F).

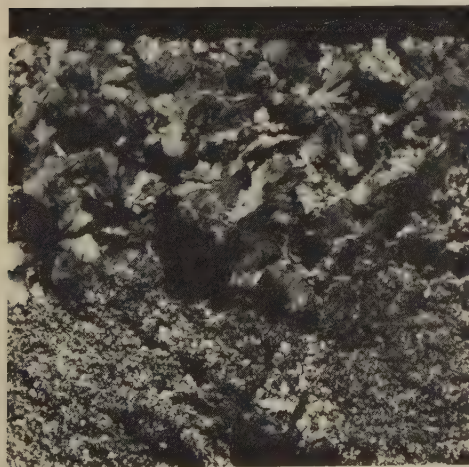
The hot tear occurred as a result of contraction during cooling in the mold. The large cleavage facets at the top of the fractograph are the origin of the tear. Note the coarse river patterns on these cleavage facets.

Fig. 22. Surface of a fracture in a 0.30% C steel casting that contained a hot tear

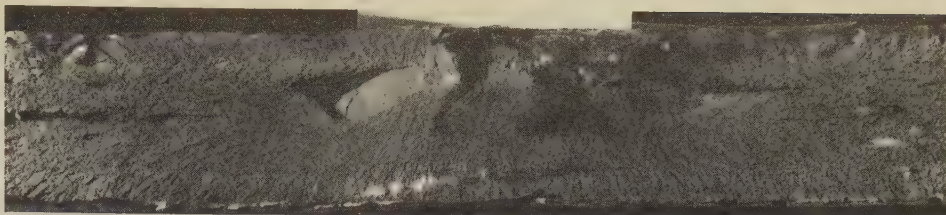
assembly weld. The crack was about 1.4 in. long, parallel to and 0.47 in. beneath the outer surface of the motor case (surface at bottom here). Radial marks are visible that confirm that fracture proceeded to the left and to the right. (Ref 6)

Fig. 23. Crack origin in the weld-related catastrophic fracture of a 260-in.-diam solid-propellant rocket motor case made of 18% Ni, grade 250, maraging steel

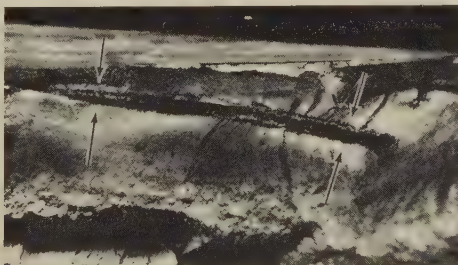
Light fractograph

3¾×

Fig. 25. A massive subsurface nonmetallic inclusion (between arrows) that initiated a bending-fatigue fracture in a carburized gear tooth of 4118 steel

Inclusions. The role of nonmetallic inclusions in initiating tensile fracture is mentioned in the discussion under "Woody Fractures" on page 29. Inclusions also serve as crack-origin sites in other types of fracture. They initiate fracture whenever their shape and location in the cross section gives rise to a serious stress concentration. Two examples of fatigue cracks originating at inclusions are shown in Fig. 24 and 25.

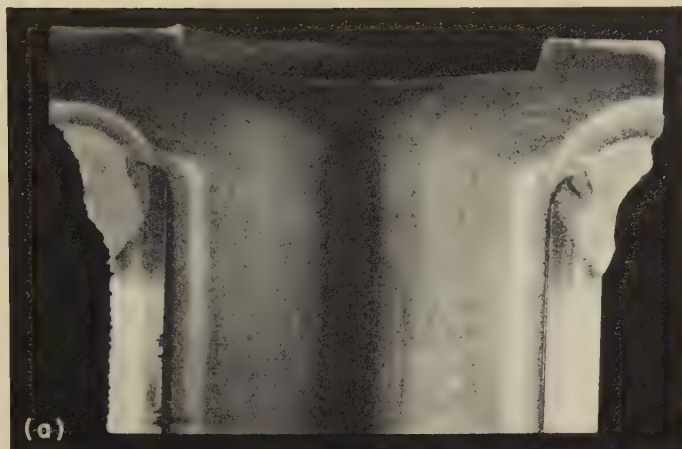
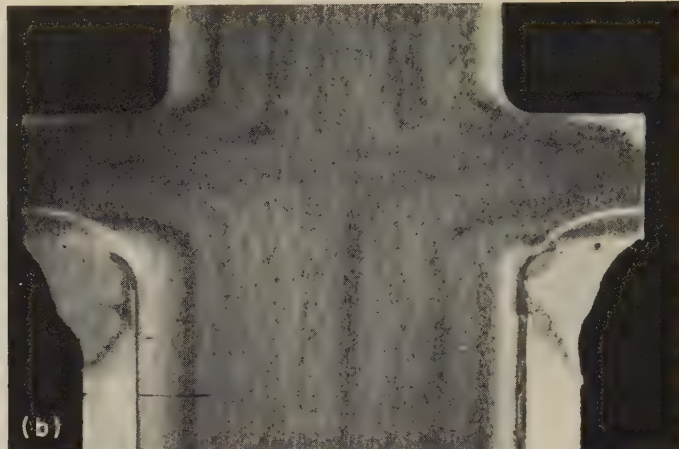
Macrographs (etchant: ammonium persulfate solution)

Both at 3×

Fig. 26. (a) Fracture in a track-bar stud initiated by centerline segregation, which was present in the bar stock. When the bar was upset to form a flange for welding, it was weakened in the flanged area, and the stud fractured at 70 ft-lb of torque on the nut. (b) A track-bar stud without centerline segregation, which did not fracture at 170 ft-lb of torque.

Segregation. Figure 26 shows two track-bar studs formed from bar stock that had been upset to form a flange for welding. The stud in Fig. 26(a) displays pronounced centerline segregation, which provided a plane of weakness within the flange after upsetting. This resulted in fracture of this stud at a torque of 70 ft-lb. The stud in Fig. 26(b), with no segregation, did not fracture at 170 ft-lb of torque on the nut; this stud shows the complete flowline pattern produced in upsetting.

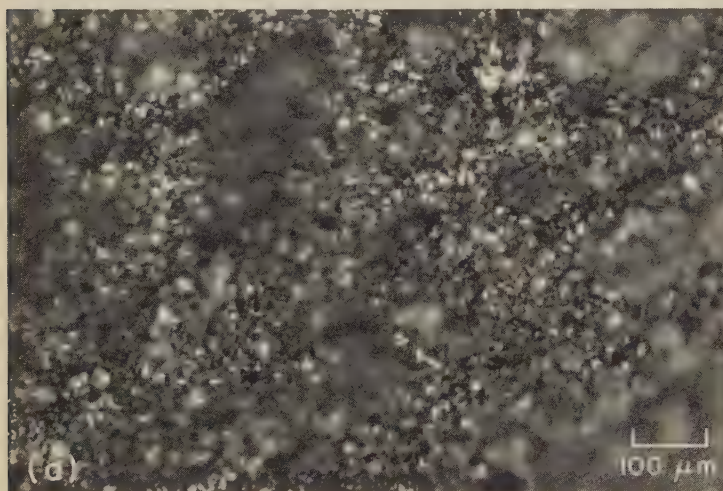
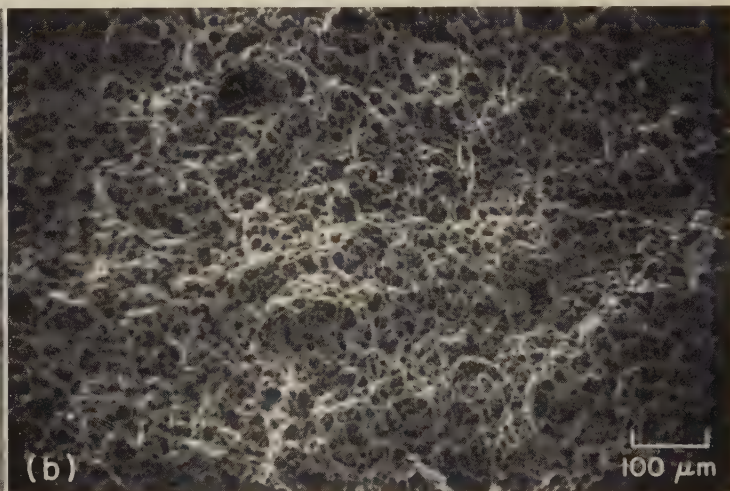
Light fractograph

100×

Fig. 27. Dimpled fracture from uniaxial tension in 1020 steel. (a) Light-microscope fractograph showing very small and quite large dimples. The bottoms of the large dimples are out of focus. (b) Scanning-electron-microscope (SEM) fractograph of a surface of the same fracture as in (a), showing sharp detail of both the small and the large dimples. Note that the large dimples have small dimples within them. See also Fig. 28 and 29, for light and SEM fractographs of this surface at higher magnifications.

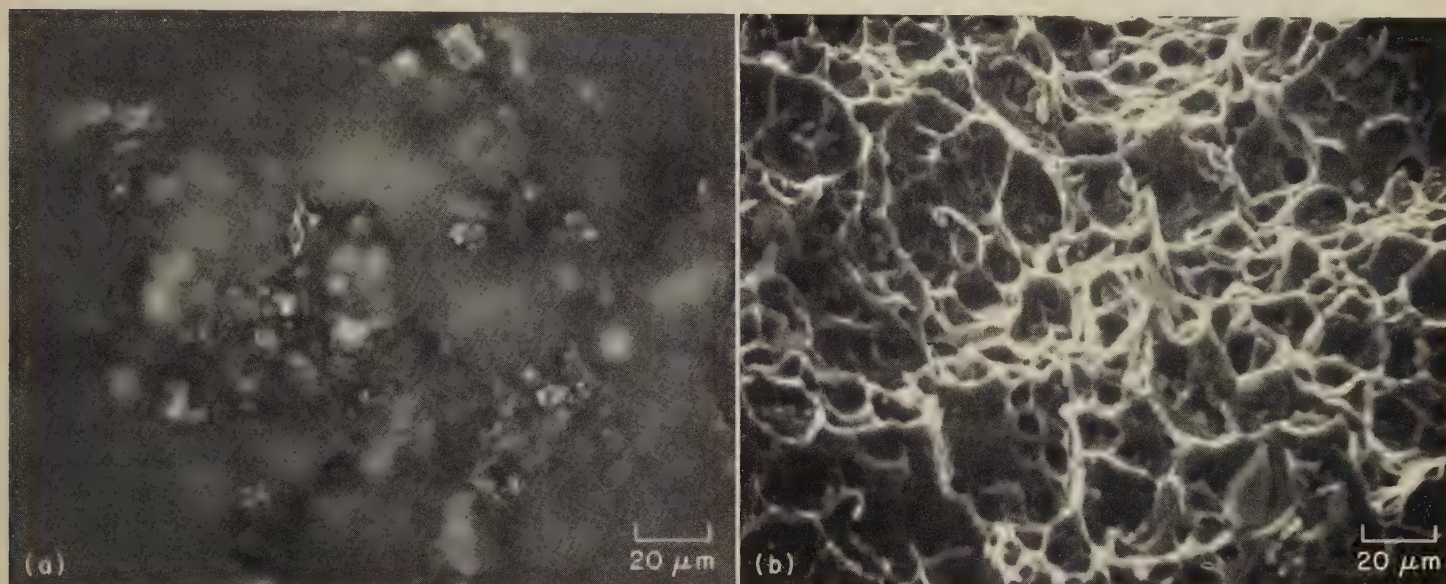
Light fractograph

500×

Fig. 29. Same steel and same features revealed as in Fig. 27 and 28, but at a still higher magnification. (a) Relatively little can be seen of the surface. Specimens with cleavage facets are more amenable to such high-magnification photography. (b) All heights and depths are shown, and small inclusions are delineated within small dimples.

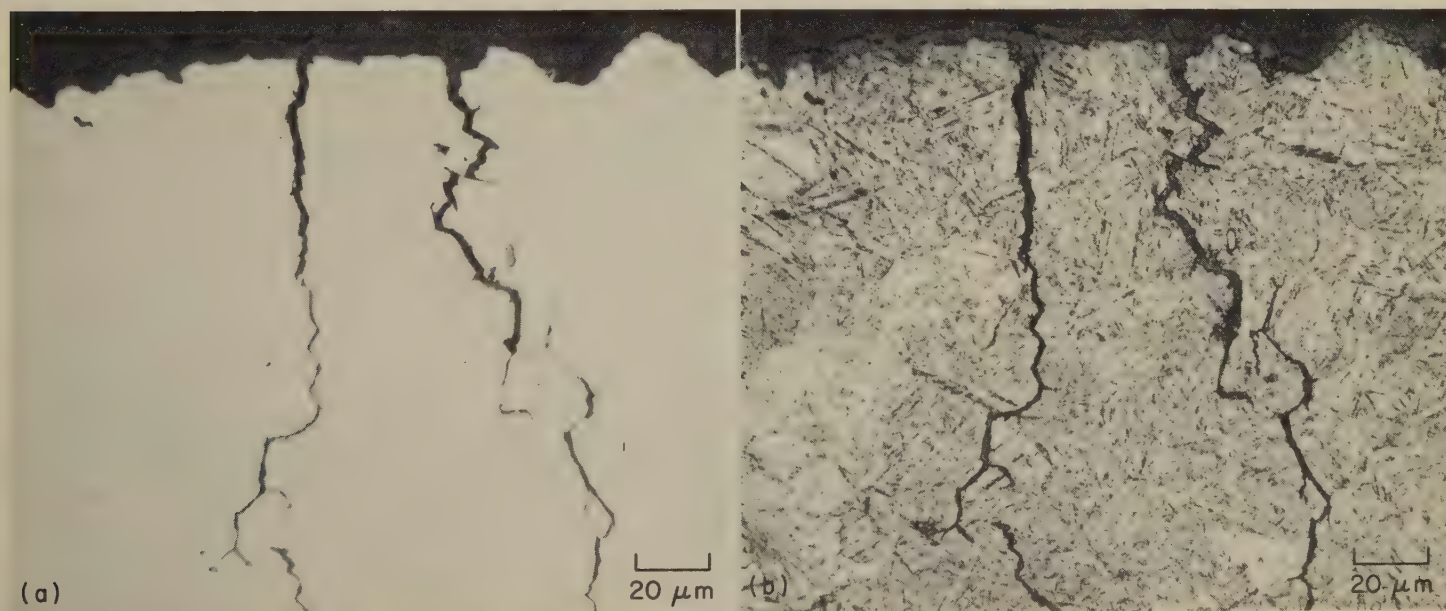
Micrograph (as polished; not etched)

500×

Fig. 30. Profile of a stress-corrosion fracture in D-6ac steel that was initiated by exposure to chlorides. Note the layer of corrosion products on the fracture surface (at top in these micrographs) and the deep secondary cracks that were formed by stress-corrosion penetration along grain boundaries. The microstructure of the steel is tempered martensite.

part, following paths that are susceptible to attack by reason of local segregation, such as grain boundaries. If the part fractures, the surfaces exposed will normally be coated with a layer of corrosion products, and secondary stress-corrosion cracking may be extensive. An example of such a fracture in D-6ac steel is shown in Fig. 30. A layer of corrosion products is visible in profile on the fracture surface, and intergranular corrosion is evident in the secondary cracks.

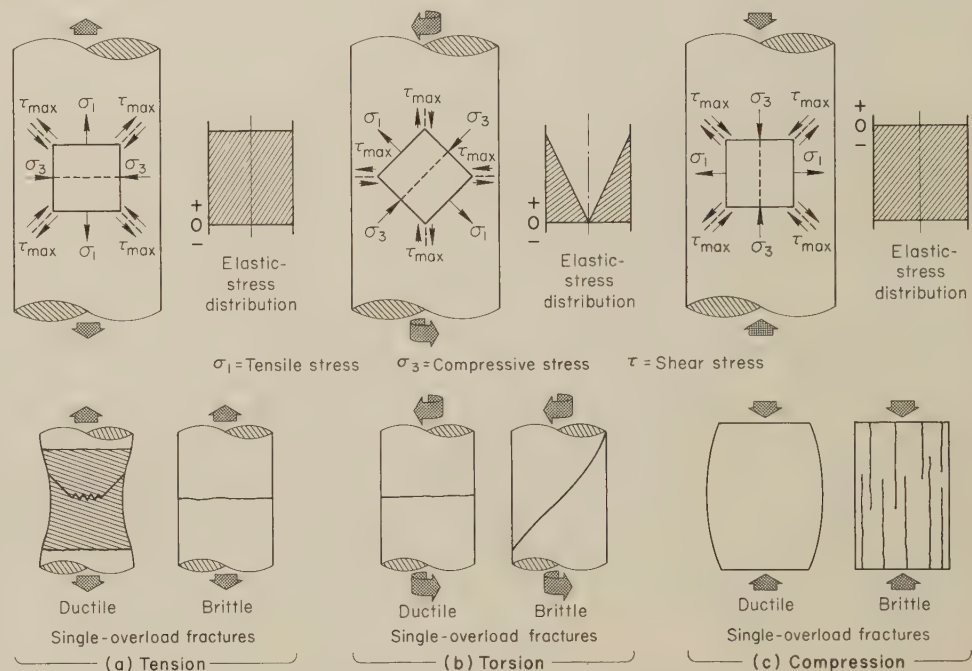
Fig. 1. Normal and shear-stress orientations under simple tension, torsion and compression of a cylinder. See text for discussion.

To illustrate these stress types, it is appropriate to review the stress directions in some simple shapes and loading conditions. Figure 1 schematically depicts the orientation of the normal and shear-stress systems at any surface or internal point in pure tension, torsion and compression. In addition, the single-overload-fracture behaviors of both ductile and brittle materials are illustrated in the sketches with each type of load. Figure 1(a) depicts a cylindrical bar under pure tension. The tensile stress component, σ_1 , is longitudinal, and the compressive stress component, σ_3 , is transverse. The shear stresses, τ , are both at 45° to the specimen axis. In a ductile material, the shear stress causes considerable deformation (elongation and necking) prior to fracture. Cracking in tension originates near the center of the specimen and propagates toward the surface, ending with a conical shear lip (group II fracture), usually at approxi-

With torsional loading as shown in Fig. 1(b), the tensile and compressive stresses are at 45° to the specimen axis, and mutually perpendicular. The shear

When a cylinder is loaded in axial compression (Fig. 1c), the compressive stress component, σ_3 , is axial, and the tensile stress component, σ_1 , is transverse. The shear stresses, τ , are at 45° to the specimen axis, as they are during axial tension loading. In a ductile material, the shear stresses again cause considerable deformation but do not usually result in fracture. The specimen simply gets shorter and bulges under the combined influence of the shear stresses and the frictional restraint imposed by the compressive load on the end faces. A brittle material in pure compression—that is, without buckling—will fracture perpendicularly to the maximum tensile stress component. Because the tensile stress is transverse, the brittle-fracture direction is longitudinal, or parallel to the axis of the specimen. The elastic-stress distribution in pure compression, in the absence of a stress concentration, is again uniform across the section. If any fracture occurs, it is likely to be in the longitudinal direction as the diameter of the specimen expands and stretches the circumference.

When a member is stressed in bending, the convex surface is stressed in tension and will have a stress distribution similar to that shown in Fig. 1(a). Conversely, the concave surface is stressed

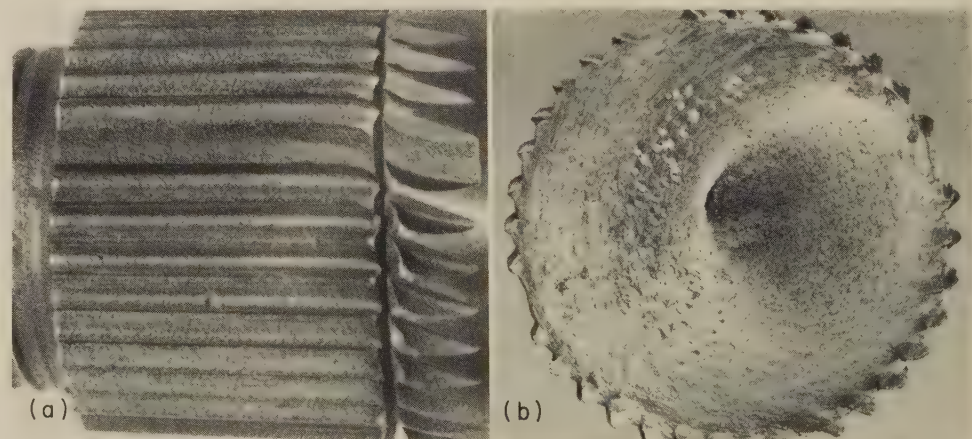
Photograph

(a) Photograph of the shaft showing the deformation of the splines in the region of fracture, which would not occur if the fracture were caused by fatigue. The shaft, 1½ in. in diameter, was made of 6118 steel and had a hardness of Rockwell C 23. Being made of a ductile metal, it was twisted in pure torsion with a single overload, yielding the fracture on the transverse shear plane shown in (b).

(b) Fracture surface of the shaft, showing the rotary deformation characteristic of a single-torsion-overload fracture in a ductile metal. If there is a combined bending component, the region of final, fast fracture will be offset from the center of the section. This type of fracture should not be confused with one resulting from rotating-bending fatigue, which does not have the gross distortion seen here.

Fig. 2. Splined shaft of 6118 steel that fractured from a single torsional overload

stresses are in the longitudinal and transverse directions. In a ductile material, the shear stresses again cause considerable deformation prior to fracture, although the deformation often is not obvious because the shape of the part is not changed except for flow on the surface (see Fig. 2a). Torsional single-overload fractures (group II) of a ductile material usually occur on the transverse shear plane, straight across the cylinder, and exhibit a telltale swirled appearance (Fig. 2b). The final-fracture area will be at the center of the bar; slight bending will cause it to be off-center. A brittle material in pure torsion will fracture in a plane perpendicular to the tensile stress component, σ_1 , which is 45° to the specimen axis (group I fracture). A spiral-type fracture is one characteristic of this type of loading and material, and can be demonstrated by twisting a piece of chalk to fracture (see Fig. 3). The elastic-stress distribution in pure torsion is maximum at the surface and zero at the center. Thus, fracture normally originates at the highest-stressed region (the surface) in pure torsion. Longitudinal torsional fractures are sometimes observed (for example, Fig. 4), because longitudinal planes have the same magnitude of shear stress as trans-

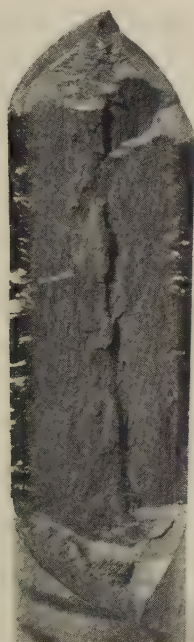
Light fractograph About 0.95×
Fig. 4. A torsional-fatigue fracture in a 1-in.-diam induction-hardened 1037 steel shaft that finally fractured in longitudinal shear. No clear point of origin is visible because the surfaces rubbed as the crack propagated.

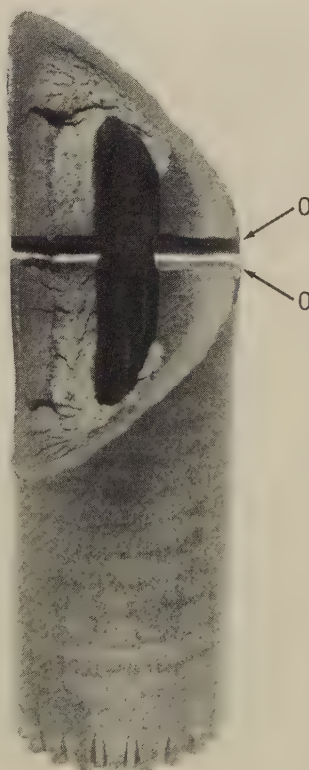
Light fractograph About 0.8×
Fig. 5. Torsional-fatigue fracture in a 1½-in.-diam induction-hardened hollow steel shaft (drilled). Fatigue crack initiated at a cross hole (at O's) and propagated in shear in the 45° tensile plane.

verse planes and longitudinal planes usually have lower toughness, due to the shape and distribution of inclusions. Additional examples of torsional-stress fractures are presented in Fig. 5 and 6.

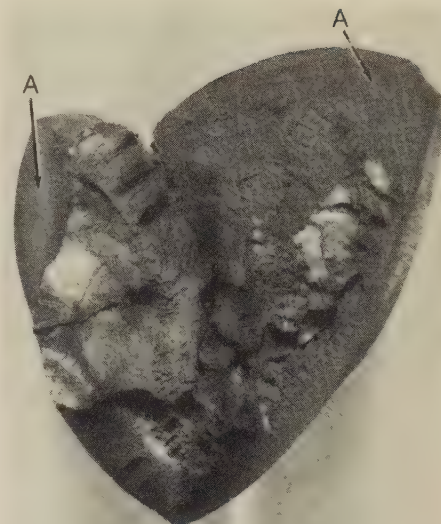
Light fractograph About 2×
Fig. 6. A final fracture by mixed tension and shear in a 1-in.-diam induction-hardened smooth 1037 steel shaft that broke as the result of torsional fatigue. Smooth areas (A) at shaft surface are initial fatigue-crack zones.

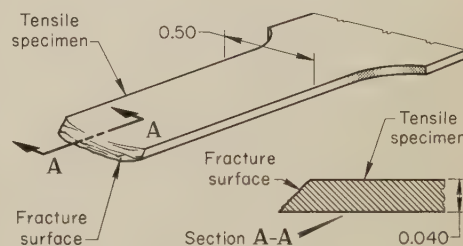
Fracture was along the direction of maximum shear stress. The fracture lacks evidence of the direction of crack propagation because chevron marks are absent.

Fig. 7. A full-slant shear fracture in a thin sheet steel specimen broken in tension

A shear fracture in a thin section (0.50 in. wide by 0.040 in. thick) is shown in Fig. 7. The fracture occurred in tension. Most of the fracture surface is at 45° to the specimen thickness—that is, in the plane of maximum shear stress. This type of fracture is often called a slant fracture and sometimes a plane-stress fracture.

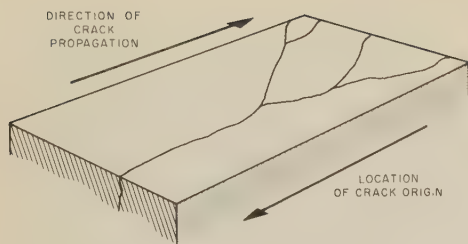
Fig. 8. Schematic representation of the information conveyed by crack branching with regard to the location of the crack origin

- 1 The direction to the crack origin is always opposite to that of crack branching, as shown in Fig. 8.
- 2 If a crack meets another at about 90°, it occurred later and the origin should not be sought in it but in the earlier crack. This is known as the T-junction method of crack-origin location (see Fig. 9).

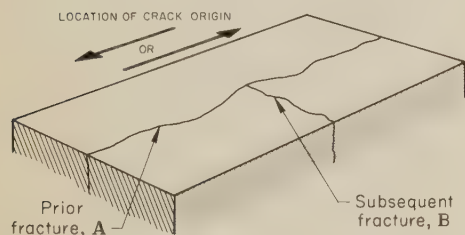
Fig. 9. Schematic representation of the T-junction method of determining which fracture surface to search to locate the crack origin. Because B does not cross A but meets it at about 90°, B occurred later and cannot contain the crack origin.

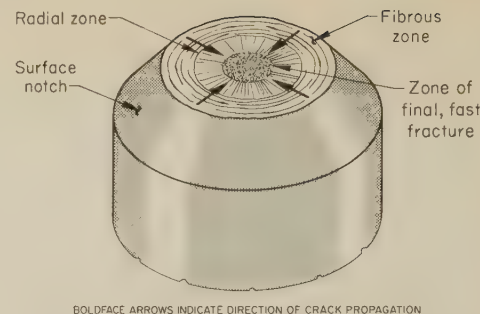
Fig. 10. Schematic representation of the fracture zones of a notched tensile specimen of circular cross section

Unlike the fractures shown for smooth (un-notched) tensile-test specimens in Fig. 2 to 4 on pages 27 and 28, this fracture contains no shear-lip zone. Initial fracture occurs completely around the specimen, in the root of the notch.

Surface notches alter the position of the crack origin, the direction of crack growth, and the sequence of fracture-zone features. Figure 10 shows schematically that, unlike the fractures in smooth (un-notched) cylindrical tensile-test specimens shown in Fig. 2 to 4 in the article on Fractographic Features Revealed by Light Microscopy (see pages 27 and 28), the fracture in a notched, cylindrical tensile-test specimen will not begin at the center of the section, but will begin at the root of the notch, with final fracture at the center of the specimen, and there will

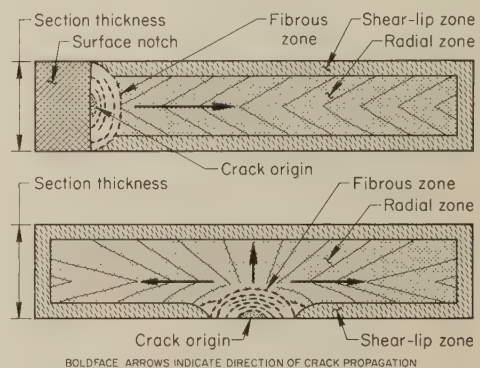
Fig. 11. Schematic representation of the fracture features that are exhibited in notched tensile specimens of rectangular cross section (Ref 4)

A fibrous zone is generated from the notch and extends for a short distance. A radial zone then supplants the fibrous zone, and a shear-lip zone is formed wherever the radial zone approaches the edge of the specimen.

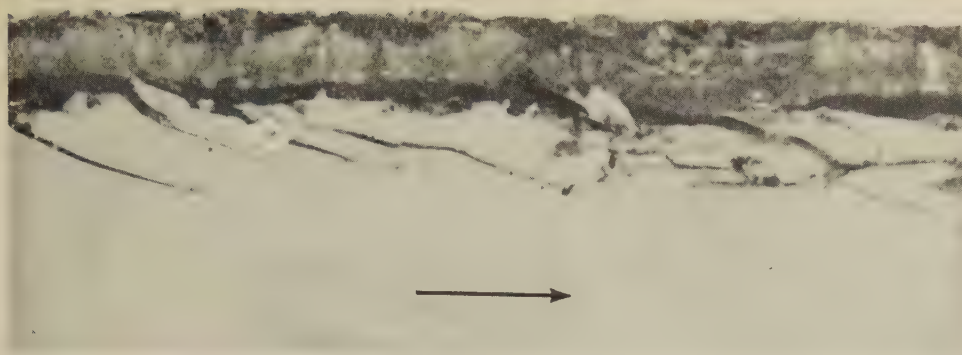
Light fractograph

5×

Fig. 12. Use of plastic tape (light gray, at bottom) to indicate the direction of crack propagation (arrow) by tears produced in the tape during fracture. Tape was applied to a motor case of 4130 steel that was proof tested by hydraulic loading. An oblique view of the fracture surface of the motor case is seen at top.

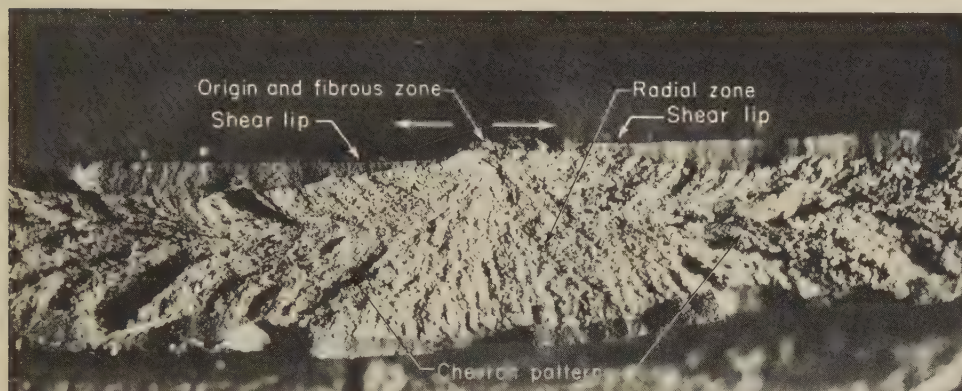
Light fractograph

6×

The shear lip increases in width with increasing distance from the origin. The radial marks below the origin and the chevron patterns to the left and right also indicate the directions of fracture.

Fig. 13. Fracture in a welded pressure vessel of 4340 steel displaying a flat origin at the top with a shear lip beginning on either side of it (Ref 4)

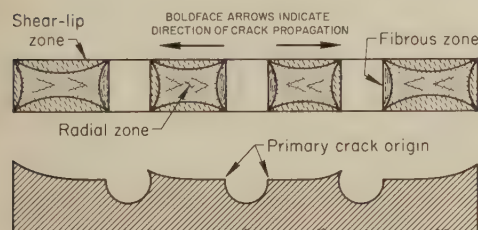
A flat area is associated with the crack origins and with each site of crack reinitiation. The interruption of the crack by a hole has created a final shear lip within the hole.

Fig. 14. A schematic representation of fracture marks associated with crack propagation that was interrupted by drilled holes (Ref 4)

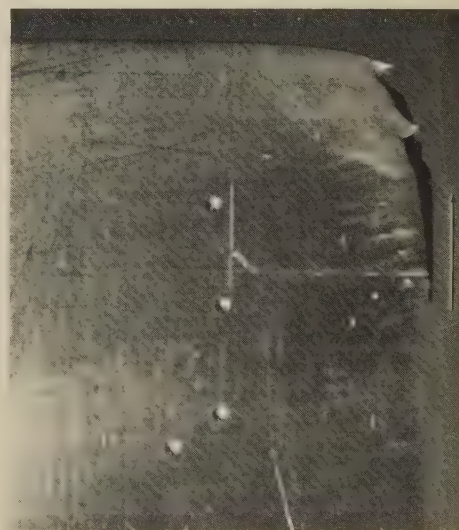
Macrograph

3×

The saw teeth at the upper right corner point back toward the crack origin. Saw teeth are sometimes useful indicators of crack origin, but are considered less reliable than the strain marks in the fractured specimen shown in Fig. 17 (at right). Arrow indicates direction of crack propagation.

Fig. 16. Fractured specimen of titanium alloy Ti-6Al-4V sheet, 0.085 in. thick, that gave an 85% ductile tear with a prominent shear lip. Fracture surface is shown in profile at right.

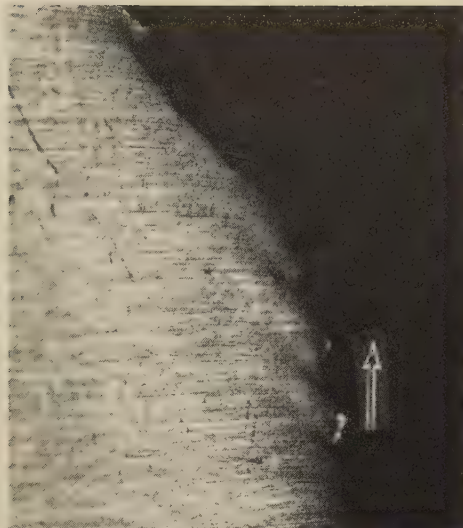
Macrograph

10½×

The shearing, at 45° to the longitudinal axis, was on a plane nearly normal to the thickness direction of the plate. The wavy strain marks at the right edge are believed to be analogous to or identical with Lüders lines. The marks formed at the edge of the crack front at various locations as it propagated. Arrow shows direction of crack propagation.

Fig. 17. Fractured specimen of titanium alloy Ti-6Al-4V sheet, 0.055 in. thick, that gave a 100% shear fracture. Fracture surface is shown in profile at right.
